PROJECT PROFILE

Pensacola Lighthouse

Repairing cracks without altering the historic appearance

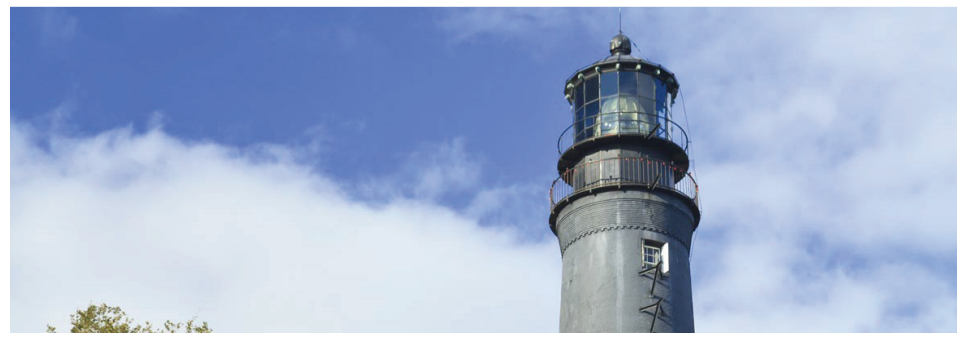
The historic Pensacola Lighthouse was built in 1859. It overlooks Pensacola Bay in Florida and stands 150 feet tall. The double brick wall structure developed vertical cracks due to moisture (water) getting inside. There is a museum connected to the base of the lighthouse that is open year round.

Custom made “biscuits” or specially designed carbon fiber plates and high -performance epoxy paste were inserted in the mortar joints, approximately 90 degrees across the cracks. The biscuits were spaced about 18" OC, giving the appearance of “stitches.” The biscuits were cut to shape to mimic the curve of the wall of the lighthouse and were counter sunk to create a seamless appearance. A repair mortar was used and the lighthouse was then re-painted to match its original colors.
